National Dam Safety Program. Tipton Dam (NDI I.D.-525), Susquehanna River Basin, Tipton Run, Blair County, Pennsylvania. Phase I Inspection Report.

TIPTON DAM

NDI I.D. NO: 525

PHASE I INSPECTION REPORT NATIONAL DAM INSPECTION PROGRAM

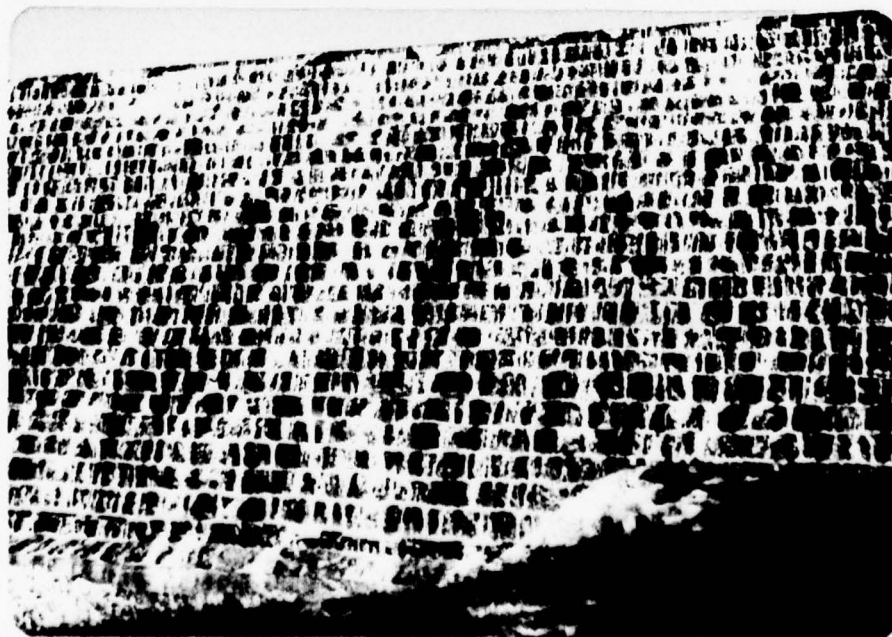
Downstream Face
